Manhole Inspection Summary

Manhole # S49GG_047MH

Record Plat: **49GG** Node: **047** Status: **Found**

Insp Date: **8/8/08 10:45 AM**

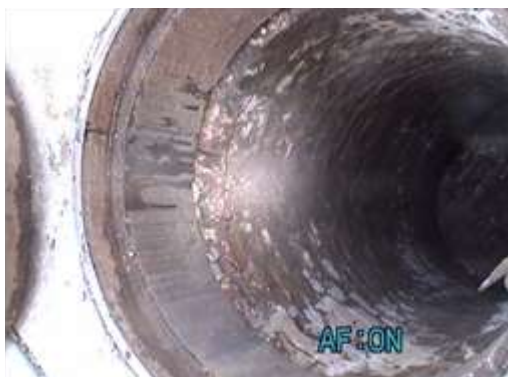
Defect 1

Infiltration

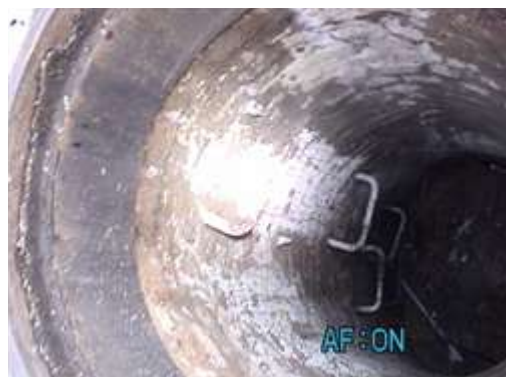
Defect 2

frame leaks

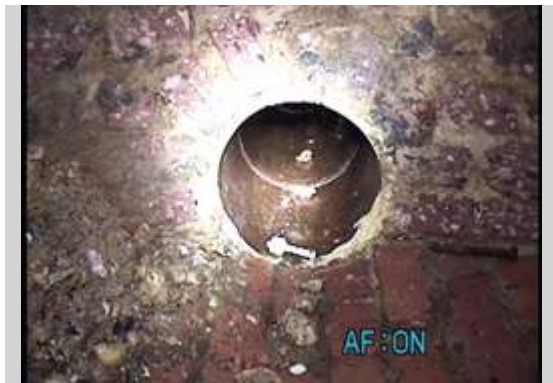
12 O'Clock Outflow

8 in. Circular Gravity Sewer
Pipe Out @ 12 O'Clock

Infiltration: **None** Pipe Seal Cond: **Sound**
